Manhole Inspection Summary

Manhole # S31AA2001MH

Location Address: **119 TAPLOW RD**

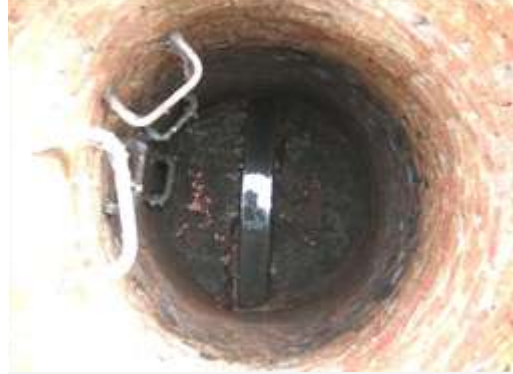
Top View

Evidence of surcharge - Bench debris.

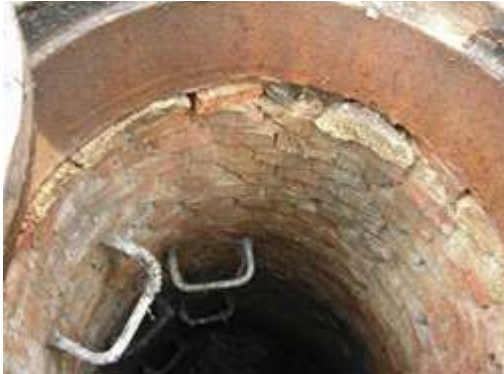
Defect

Frame leaks. Adjustment deterioration, loose brick and infiltration. Barrel infiltration.

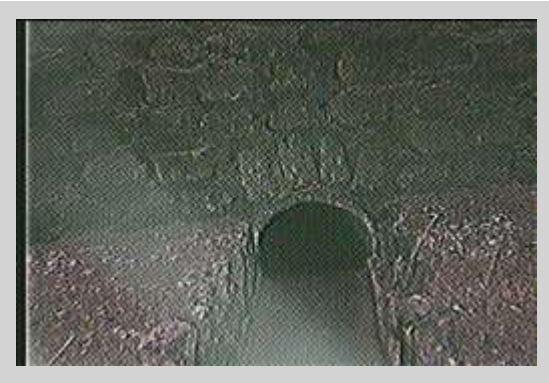
8 in. Circular Gravity Sewer Pipe Out @ 12 O'Clock

Barrel deterioration and infiltration. Channel deterioration.

Infiltration: **Evidence** Pipe Seal Cond: **Cracked**

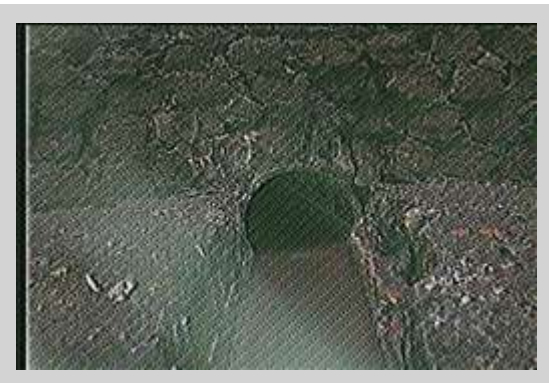
8 in. Circular Gravity Sewer Pipe In @ 6 O'Clock

Barrel deterioration and infiltration.

Infiltration: **Evidence** Pipe Seal Cond: **Cracked**
